## **WILSDEN ROAD SAFETY TRUST PROJECT**

Harecroft: an evaluation of how to apply psychological speed reductions through a rural hamlet through incremental changes in visual deterrents over a fixed period of time

Wilsden Parish Council

September 2022

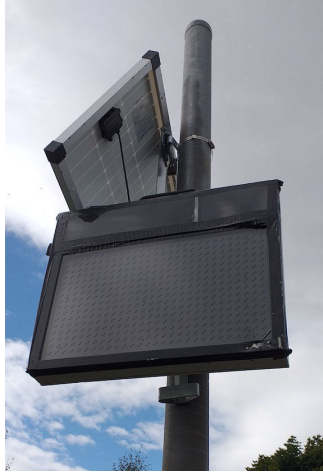
Picture 1

1. A SID was erected approximately 100 metres inside the 20 mph zone in each direction.
2. The recording component of the SIDs were switched on immediately, but the visual displays were switched off (to operate in stealth mode) and red and white screen surrounding tape was covered over so that the device did not appear to be a traffic device – see picture 1

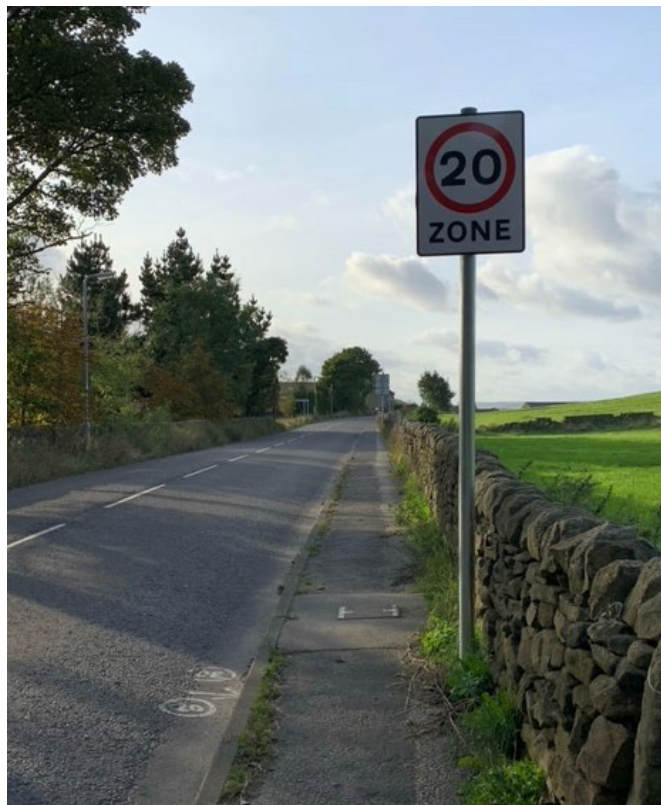
Picture 2

4. The Westbound 20 mph zone starts well outside the start of any residential properties, see picture 2 below. It is believed the siting of this so far from properties has confused drivers who could not see the need for such a reduced speed and used their own judgement to drive to road surroundings. The positioning would be to advance the zone a further 100 metres to the edge of housing for driver association.
